**Flood Control Project Maintenance
Levee Inspections**

Maintenance Issue Types Only, Levee Inspection Report By Mile - Fall 2016

Sutter Maintenance Yard Tisdale Bypass

Waterway	Bank	Unit Miles	Inspection Start/End	Inspector
Unit No. 01 Tisdale Bypass	Left	4.51	11/02/2016 11/02/2016	Tariq Chechi

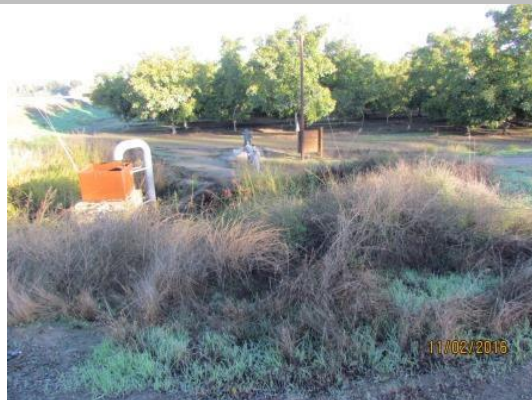
Photo 1 of 1 : FA_2016_ST0009_286_10_20161107_00008.jpg

LM Start	0.03	Rating **	M	Issue No.	10
LM End	0.03	Issue Type +	Ma	Location *	LS
Category	Earthen Levee			GPS Latitude/Longitude	
				Start	End
Item	Vegetation			39.027253 °	39.027253 °
				-121.821330 °	-121.821330 °
DWR ID	DWR_ST0009_01_f_2016_10				
Comment Code					
V1 : Control annual grass and weeds on the levee slopes and easements.					
Inspector Comment

View of grass taller than 12 inches blocking visibility.

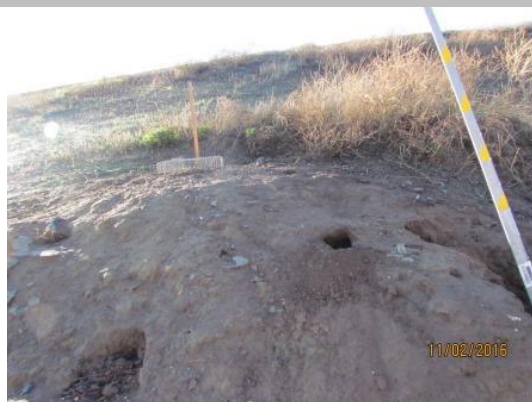
Photo 1 of 1 : FA_2016_ST0009_286_11_20161107_00009.jpg

LM Start	2.11	Rating **	M	Issue No.	11
LM End	2.11	Issue Type +	Ma	Location *	LS
Category	Earthen Levee			GPS Latitude/Longitude	
				Start	End
Item	Animal Control			39.028392 °	39.028392 °
				-121.782887 °	-121.782887 °
DWR ID	DWR_ST0009_01_f_2016_11				
Comment Code					
A3 : No rodents visible, but rodent burrows visible; need to backfill and compact or grout burrows.					
Inspector Comment

View of the rodent holes along the landside slope.

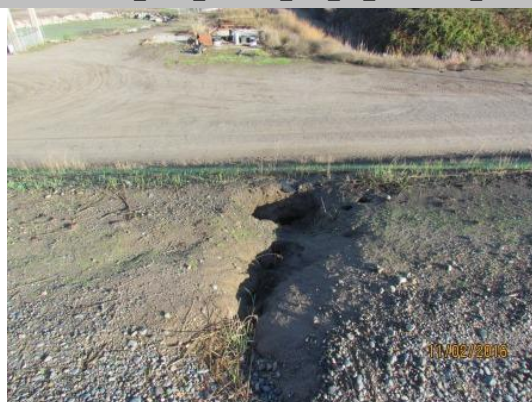
Photo 1 of 2 : FA_2016_ST0009_286_12_20161107_00010.jpg

LM Start	2.16	Rating **	U	Issue No.	12
LM End	2.16	Issue Type +	Ma	Location *	LS
Category	Earthen Levee			GPS Latitude/Longitude	
				Start	End
Item	Animal Control			39.028137°	39.028137°
				-121.782020°	-121.782020°
DWR ID	DWR_ST0009_01_f_2016_12				
Comment Code					
A3 : No rodents visible, but rodent burrows visible; need to backfill and compact or grout burrows.					
Inspector Comment

View of a rodent hole along the levee crown.

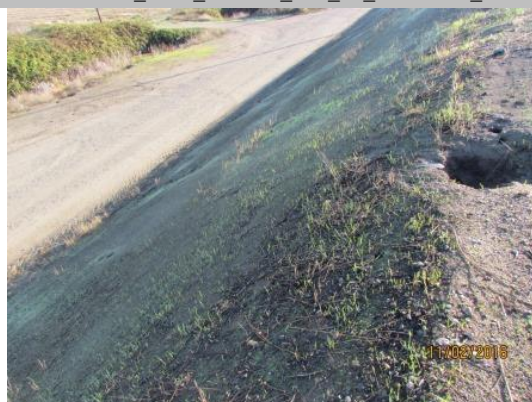
Photo 2 of 2 : FA_2016_ST0009_286_12_20161107_00012.jpg

LM Start	2.16	Rating **	U	Issue No.	12 (cont)
LM End	2.16	Issue Type +	Ma	Location *	LS

Another view of the rodent holes along the crown and landside slope.

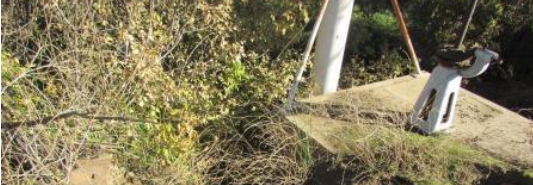
Photo 1 of 2 : FA_2016_ST0009_287_13_20161107_00017.jpg

LM Start	1.01	Rating **	C	Issue No.	3
LM End	1.01	Issue Type +	Ma	Location *	WS
Category	Earthen Levee			GPS Latitude/Longitude	
				Start	End
Item	Erosion / Bank Caving			39.025542°	39.025542°
				-121.802468°	-121.802468°
DWR ID	DWR_ST0009_02_s _ 2012_3				
Comment Code					
E1 : Note and monitor erosion site.					
Inspector Comment					
Sutter Yard needs to monitor the erosion.

View of the erosion along the concrete vault.

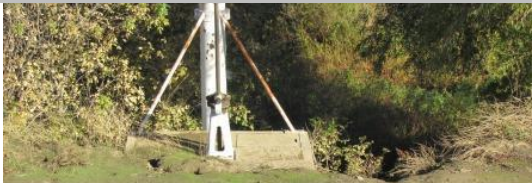
Photo 2 of 2 : FA_2016_ST0009_287_13_20161107_00019.jpg

Another view of the erosion along the concrete vault.

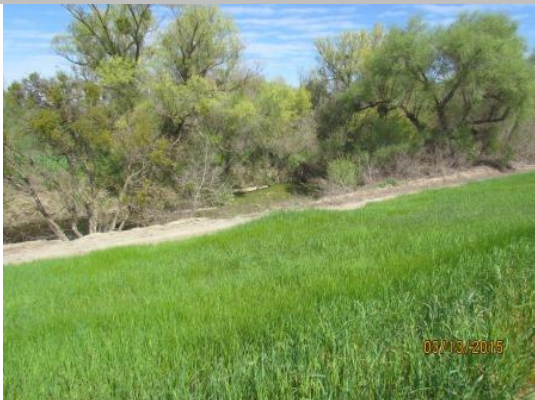
Photo 1 of 1 : FA_2016_ST0009_287_290_20160823_00010.jpg

View of the erosion along the waterside berm.

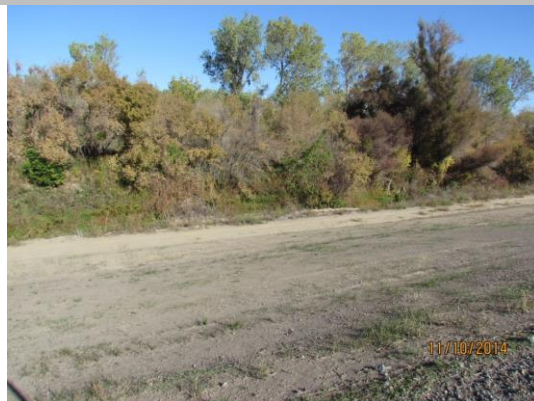
Photo 1 of 1 : FA_2016_ST0009_287_4_20160823_00004.jpg

LM Start	1.29	Rating **	M	Issue No.	4
LM End	1.29	Issue Type +	Ma	Location *	WS
Category	Earthen Levee			GPS Latitude/Longitude	
				Start	End
Item	Erosion / Bank Caving			39.025478 °	39.025478 °
				-121.797232 °	-121.797232 °
DWR ID	DWR_ST0009_02_s _ 2013_4				
Comment Code					
E2 : Schedule repair of erosion site prior to the next inspection.					
Inspector Comment					
Sutter Yard needs to monitor the erosion.

View of the erosion along the waterside berm.

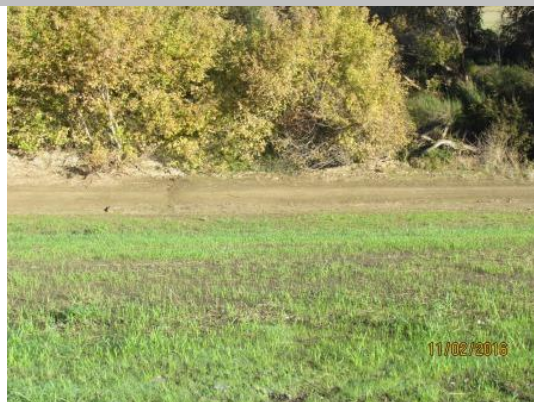
Photo 1 of 1 : FA_2016_ST0009_287_5_20161107_00021.jpg

LM Start	1.48	Rating **	M	Issue No.	5
LM End	1.50	Issue Type +	Ma	Location *	WS
Category	Earthen Levee			GPS Latitude/Longitude	
				Start	End
Item	Erosion / Bank Caving			39.025460 °	39.025446 °
				-121.793815 °	-121.793347 °
DWR ID	DWR_ST0009_02_s _ 2013_5				
Comment Code					
E2 : Schedule repair of erosion site prior to the next inspection.					
Inspector Comment					
Sutter Yard needs to monitor the erosion.

View of the erosion along the waterside berm.

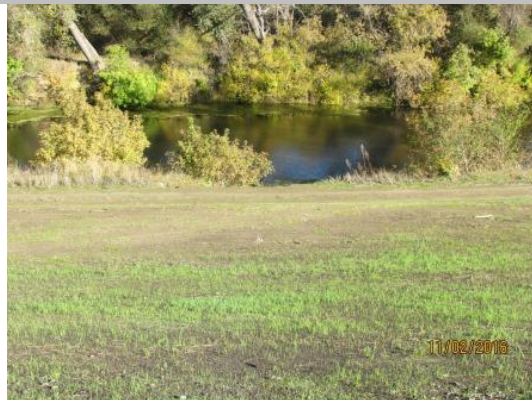
Photo 1 of 1 : FA_2016_ST0009_287_2_20161107_00020.jpg

LM Start	3.93	Rating **	M	Issue No.	2
LM End	3.93	Issue Type +	Ma	Location *	WS
Category	Earthen Levee			GPS Latitude/Longitude	
				Start	End
Item	Erosion / Bank Caving			39.025060 °	39.025060 °
				-121.748178 °	-121.748178 °
DWR ID	DWR_ST0009_02_f_2016_2				
Comment Code					
E1 : Note and monitor erosion site.					
Inspector Comment

View of the erosion along the waterside berm.
